Manhole Inspection Summary

Manhole # S35C__059MH

Insp Date: **8/5/08 3:39 PM**

Location Address: **side 201 bath st**

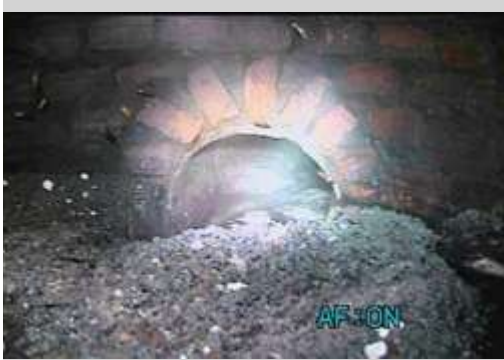
Defect 3

Condition: ☐ Sound ☐ Cracked ☐ Root Intrusion ☐ Deteriorated ☐ Leaks ☒ **Debris**

channel debris

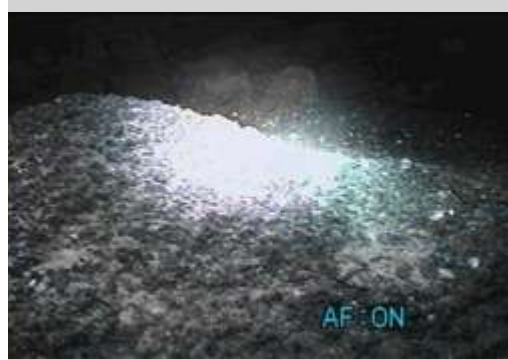
Defect 2

Condition: ☐ Sound ☐ Cracked ☐ Root Intrusion ☐ Deteriorated ☐ Leaks ☒ **Debris**

bench debris

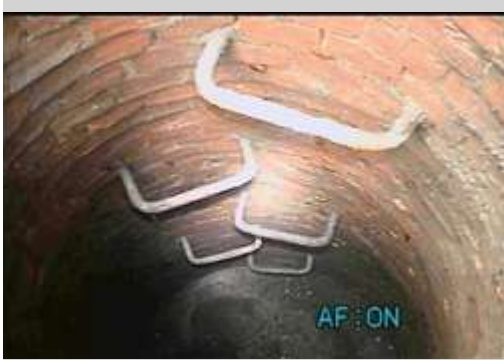
Defect 1

Steps Count: **5** Missing: **0** ☒ **Corroded**

steps

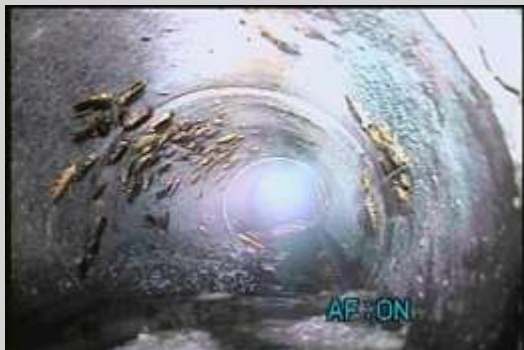
12 O'Clock Outflow

10 in. Circular Gravity Sewer
Pipe Out @ 12 OClock

cant back up

Invert Depth: 9.41 (ft.) Flow Characteristics: Slow

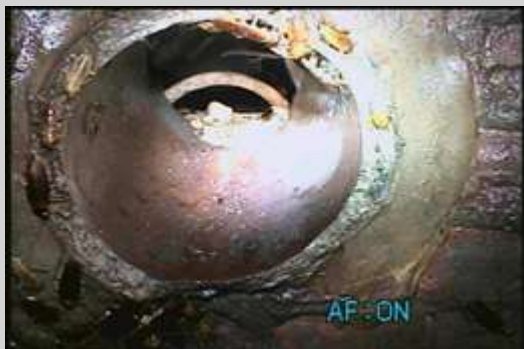
5 O'Clock Inflow

10 in. Circular Gravity Sewer
Pipe In @ 5 OClock

Drop In @ 5 OClock

Invert Depth: 6.16 (ft.) Flow Characteristics: Slow

Drop: Outside Direct
